## **RESEARCH ARTICLE**

# **Socio-Ecological Resilience and Geomorphic Decay: A Study of Riparian Biodiversity and Anthropogenic Stress in the Pampa River Basin, Kerala, India**

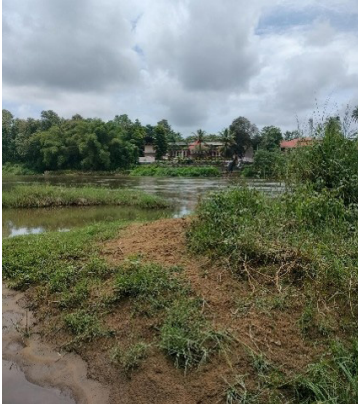
Fig.1: Cherukole

- Cherukolpuzha (C): A depositional area focused on Sediment Accretion Dynamics. (Lat: 9° 19' 20" N; Long: 76° 40' 50" E).
- Keezhukara (K): A historical hotspot of Intense Substrate Removal. (Lat: 9° 20' 52" N; Long: 76° 46' 45" E).

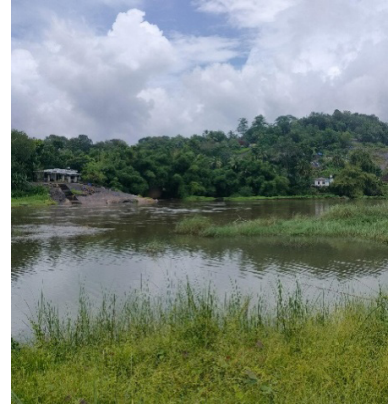
Fig.3: Maramon

- Maramon (M): An area characterized by Intense Bank Scour and Slumping. (Lat: 9° 20' 25" N; Long: 76° 41' 35" E).

At Maramon region, the study recorded complete absence of deep-rooted riparian trees. Instead, the banks are covered in a dense carpet of shallow-rooted plants. The deep-rooted trees were reported to develop a strong taproot system with deep vertical penetration along with extensive lateral roots, which enables firm anchorage in riverbanks and high resistance to erosion and flood scouring. Classical Indian silvicultural literature explicitly describes *Terminalia arjuna* (Roxb.Ex DC.) Wright & Arn. (Maruthu in Malayalam) as a riverine species adapted to alluvial banks with deep, binding roots suited for bank stabilization (Troup, 1921). The tree was also reported to grow in some parts of Pampa river bank (Kerala State Biodiversity Board, 2018). Its ecological role in riparian zones has also been supported by broader riparian research, where deep-rooted trees contribute to long-term bank strength and resistance to hydraulic shear stress (Naiman & Décamps, 1997). Although several other riparian species in Kerala, such as *Ficus*
